Table of Contents for 2818 Rio Grande Tree Permit
Heritage Tree Variance Package

PROJECT NAME: 2818 Rio Grande

TREE PERMIT #: 10827869

REQUEST: The applicant is requesting to remove a heritage tree with a stem greater than 30" in diameter.

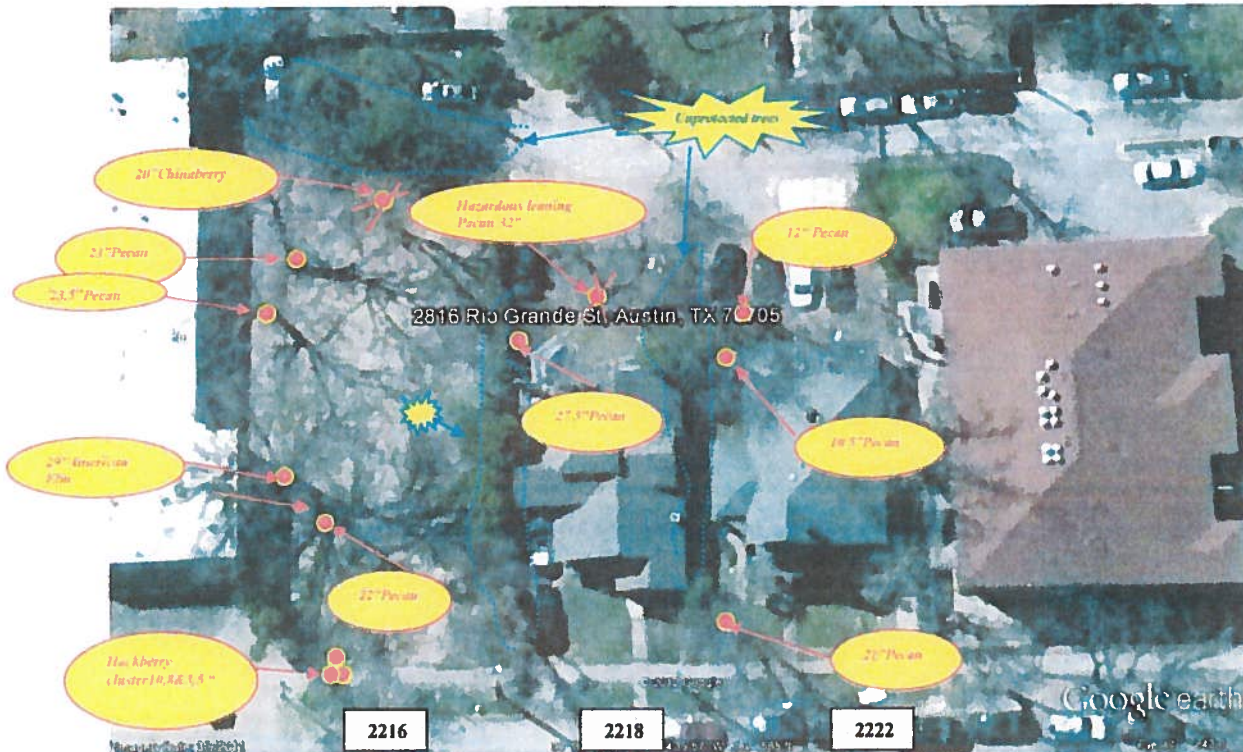
- ❖ American Elm Tree 29" (*Ulmus americana*) is considered- Average- in- condition.
- ❖ All Pecan Trees (*Carya illinoensis*) are in Above Average- to- Excellent in condition; *With the exception of the 32" on lot 2218, NOTE: it is leaning at a 45 degree angle and is very top heavy, This Pecan tree needs to be removed. Due to the liability. It is Poor in condition. (see photo).
- ❖ Cluster of Common Hackberry Trees (*Celtis occidentalis*) in City right-of- way, are weak and considered Poor- in- condition.
- ❖ Chinaberry Tree 20" (*Melia azedarach*) is considered an invasive species
- ❖ Remaining Trees and shrubs are less than 8" can be removed without tree permit.
